Presentation of Serbian sectors 18 to 23

Preparation of Documentation for River Training and Dredging Works on Selected Locations along the Danube River. A project funded by the European Union

23. Sector – Beska (km 1,232.0 – 1,226.6)

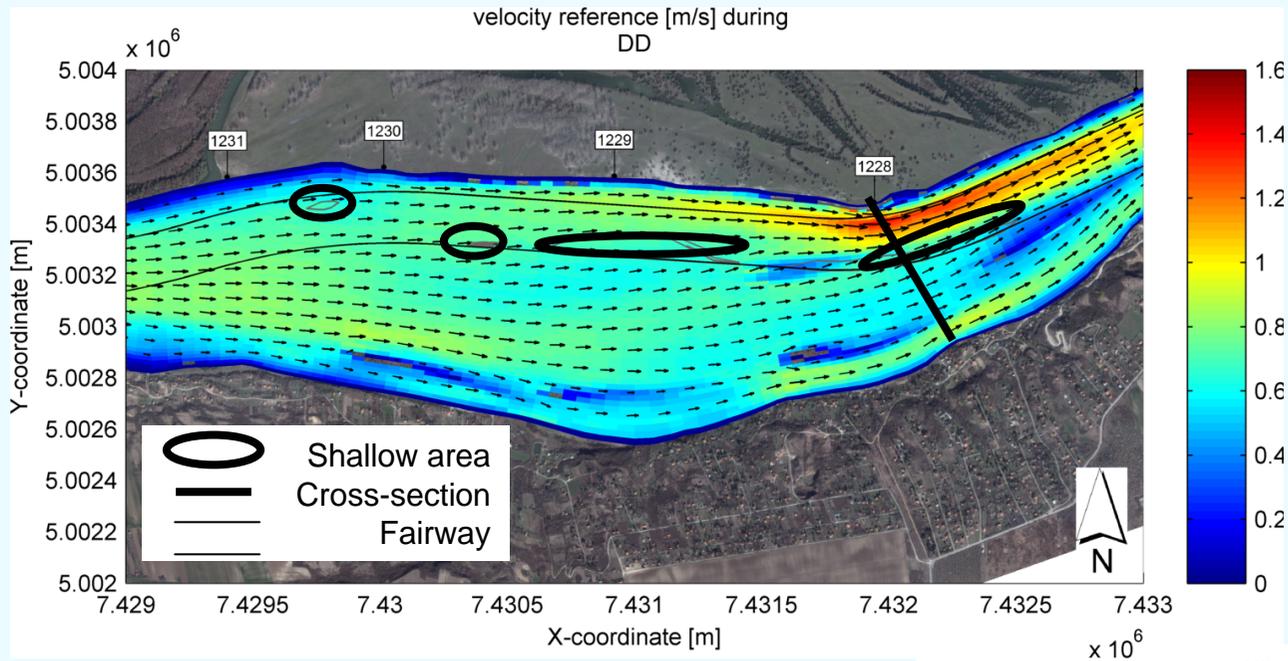
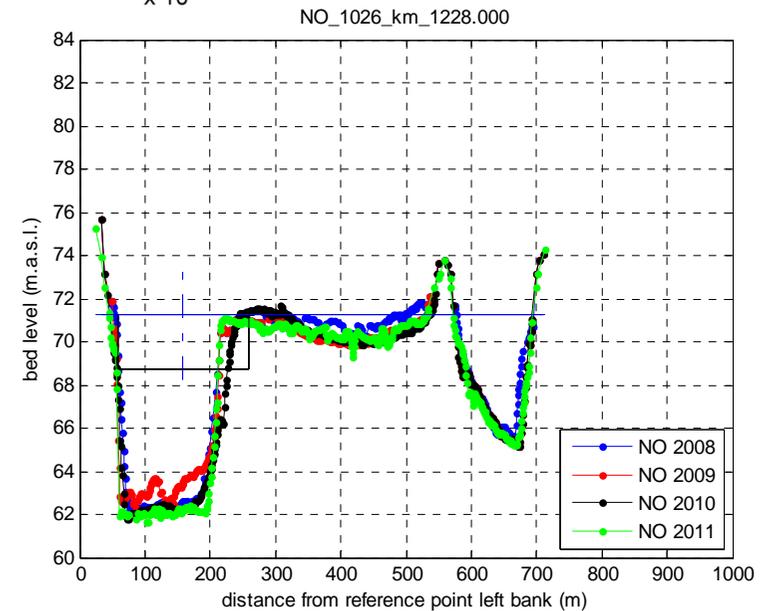
23. Beska – Existing situation

Navigation problems:

- fairway is protruded by sand bars on four locations in sector

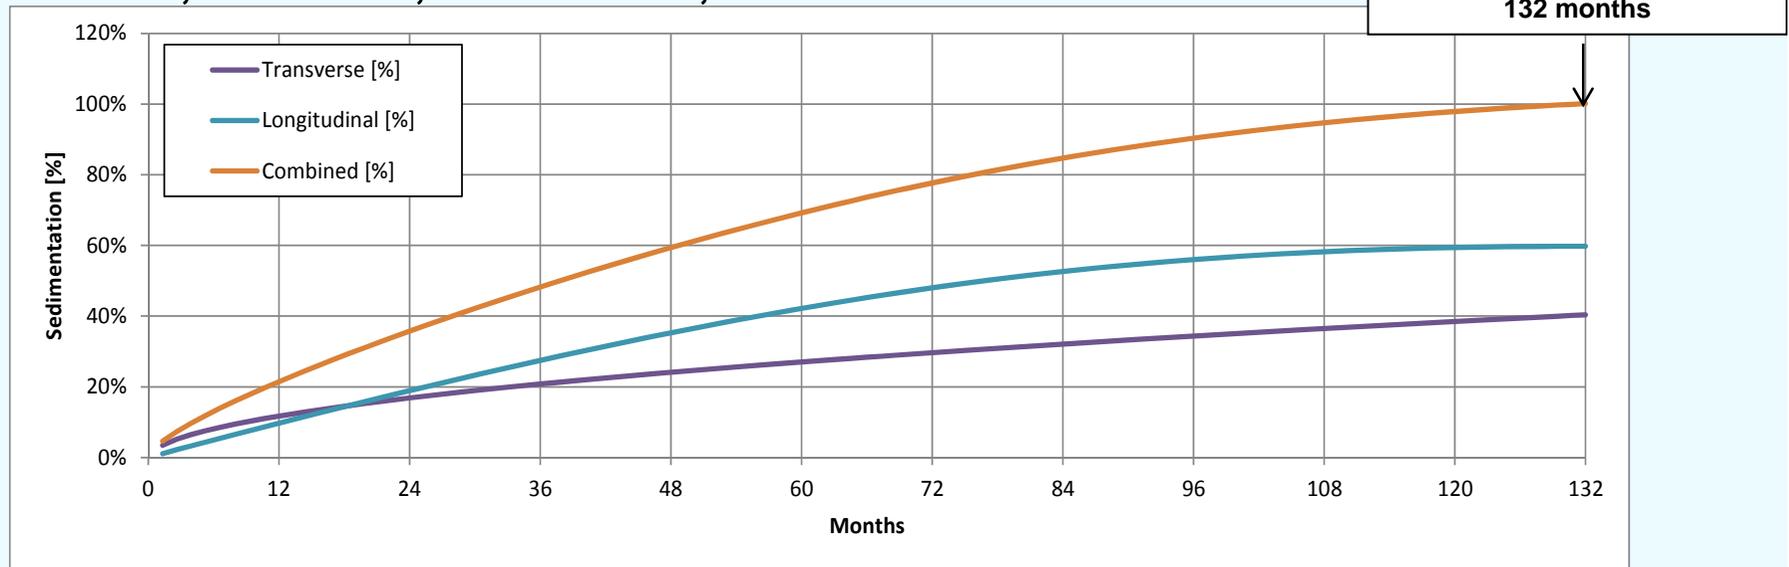
23. Beska – option 2: dredging

Km 1,228.2-1,227.6: 68,901 m³

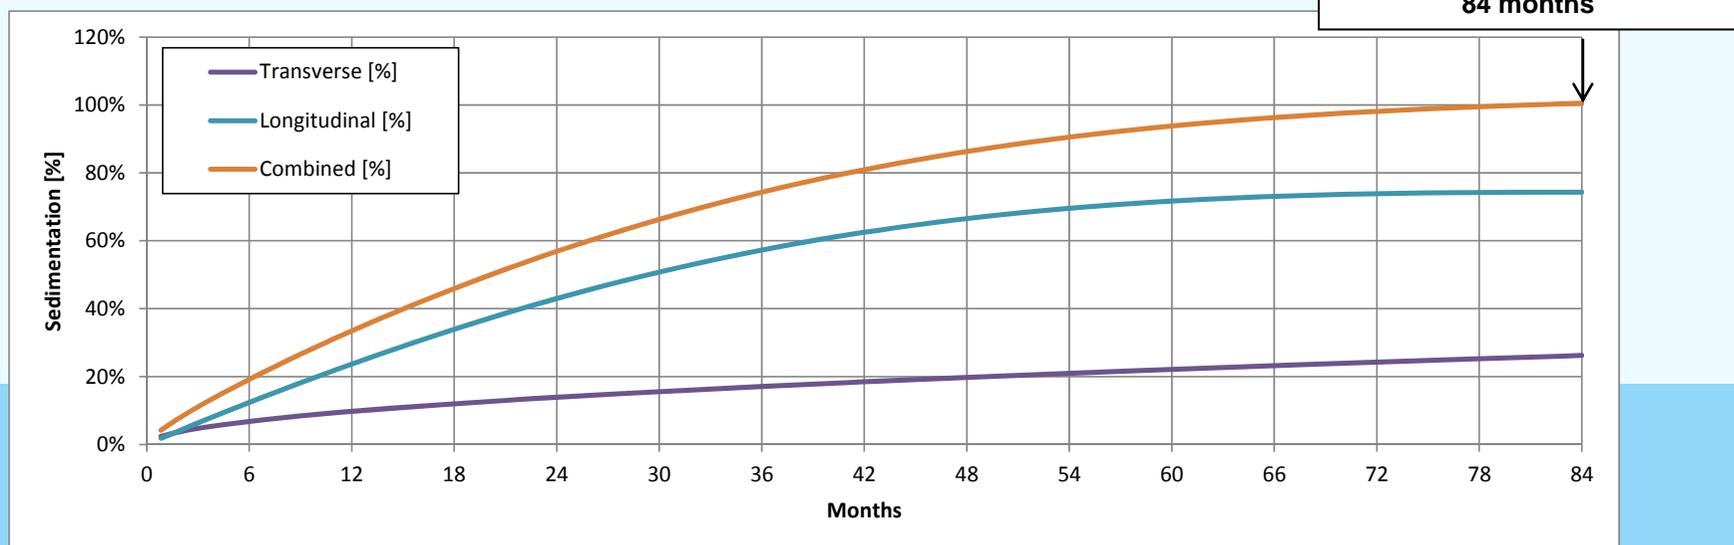
Km 1,229.2-1,228.6: 88,187 m³
